Coolant Temperature Gauge Replacement Procedure

#1 This Kit contains the following;

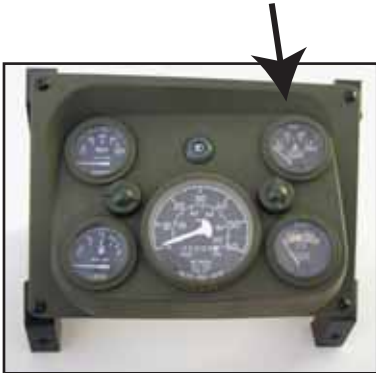
Remove this gauge.

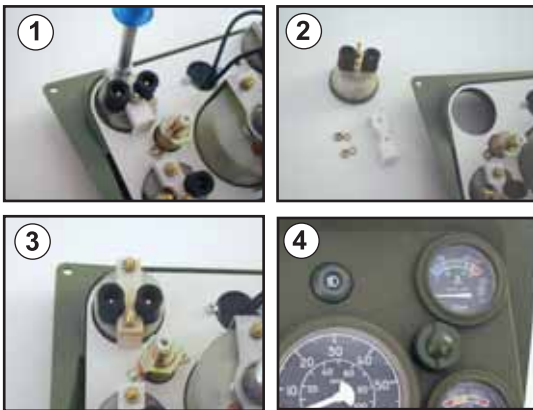
#2 Remove and replace temperature gauge. The Instrument Panel (IP), in the vehicle you are working on to change the coolant temperature gauge to the upgraded version with LED warning light should look like the one shown here. If it does not, check with your superior or motor pool supervisor to confirm work to be performed.

Remove the Coolant Temperature gauge found in the upper right hand corner of the IP, (front view or, the upper left hand corner, rear view) This is the gauge with a range of 100 to 240 degrees Fahrenheit.

#3 Disconnect electrical leads, (if IP is still connected), loosen 2 #10 nuts, remove nuts, split washers and mounting clamp. Remove instrument from IP and install new Temperature gauge using nuts washers and mounting clamp provided.

NOTE: JUST 6 OR 7 INCH POUNDS (.8 nm) of torque are needed to secure gauge into panel. (OVER TIGHTENING MAY CAUSE INCORRECT READINGS OR PREVENT THIS INSTRUMENT FROM FUNCTIONING). Re-connect electrical leads and re-install IP.
